**Land Use, Vegetation Types and Erosion Patterns in
Selected Catchments of the Keiskamma River Basin,**

**Submitted in fulfilment of the requirements for
the degree of Master of Science**

**In the
Faculty of Science & Technology at the
University of Fort Hare
Eastern Cape**

2003

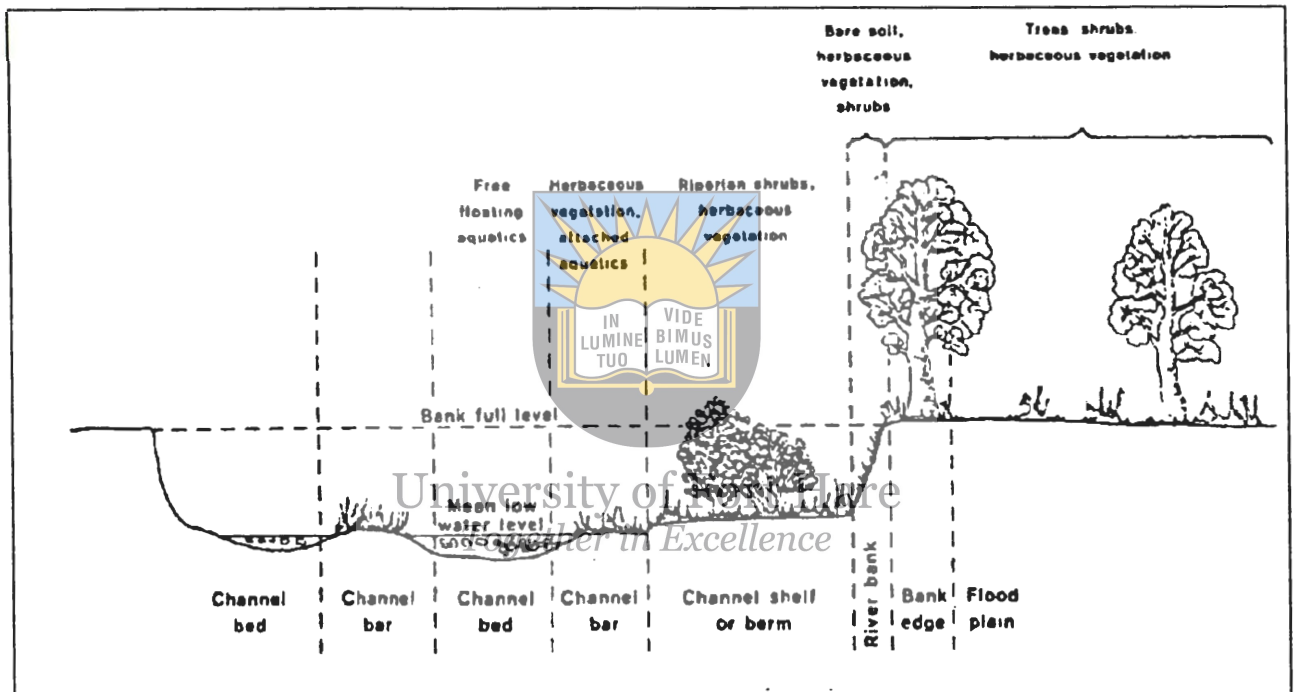
Figure 2 Riverine geomorphic features and associated vegetation types (Hupp, 1990)

The channel bed of a perennial stream is the surface that is wholly or partly covered by flows below mean discharge. Thus, at least part of the channel bed of a perennial stream is inundated at all times (Hupp, 1990). In contrast, the channel bar is an area of accretion raised slightly above the mean low water levels. This part of the channel is inundated for about 40 per cent of the time (in perennial streams) and provides a habitat for herbaceous plants such as reeds and herbs, which are rooted in the substrate.

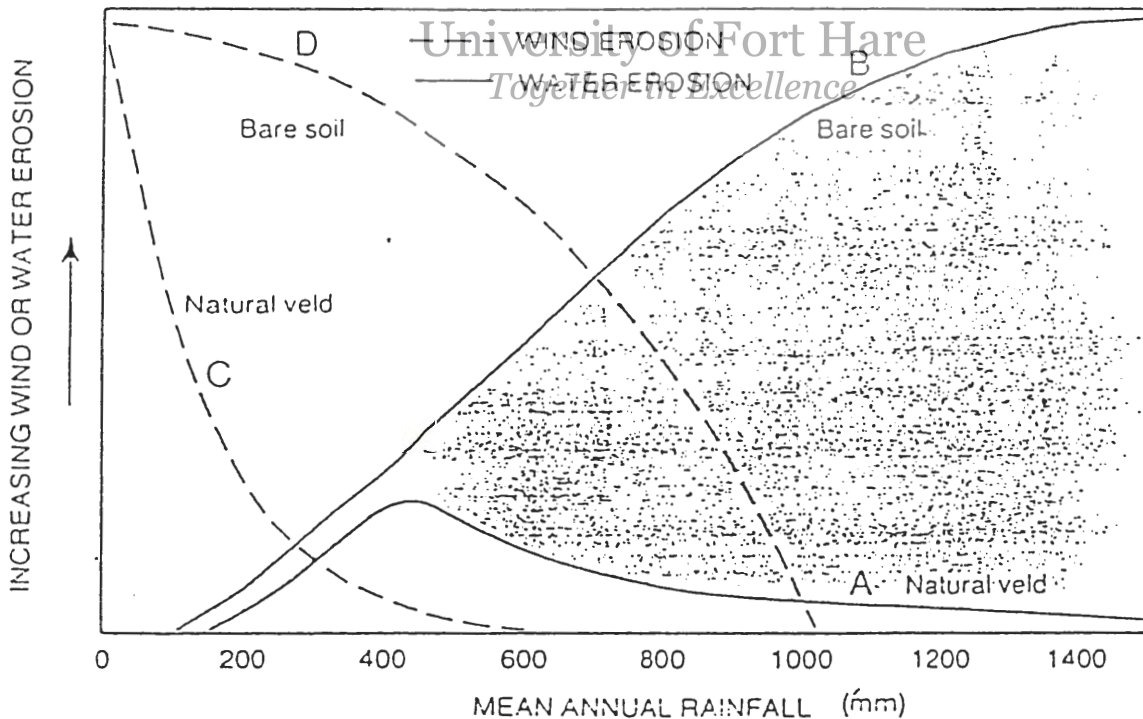
Figure 3 Relationship of water and wind erosion for bare soil (B, D) and natural veld (A, C) with increasing rainfall (Van Oudtshoorn, 1992)

Curve A represents natural veld and shows water erosion increasing from arid to semi-arid conditions. It therefore decreases as rainfall and vegetative cover improve. Curve B reflects water erosion from bare soil. Curve C and D relate to wind erosion and reflect very different relationships. Wind erosion in arid areas, even in natural veld, can be very severe, especially where sandy soils predominate. When the amount and distribution of rainfall as well as vegetative cover improve, the hazard of wind erosion is greatly reduced, even for bare soil (Van Oudtshoorn, 1992).

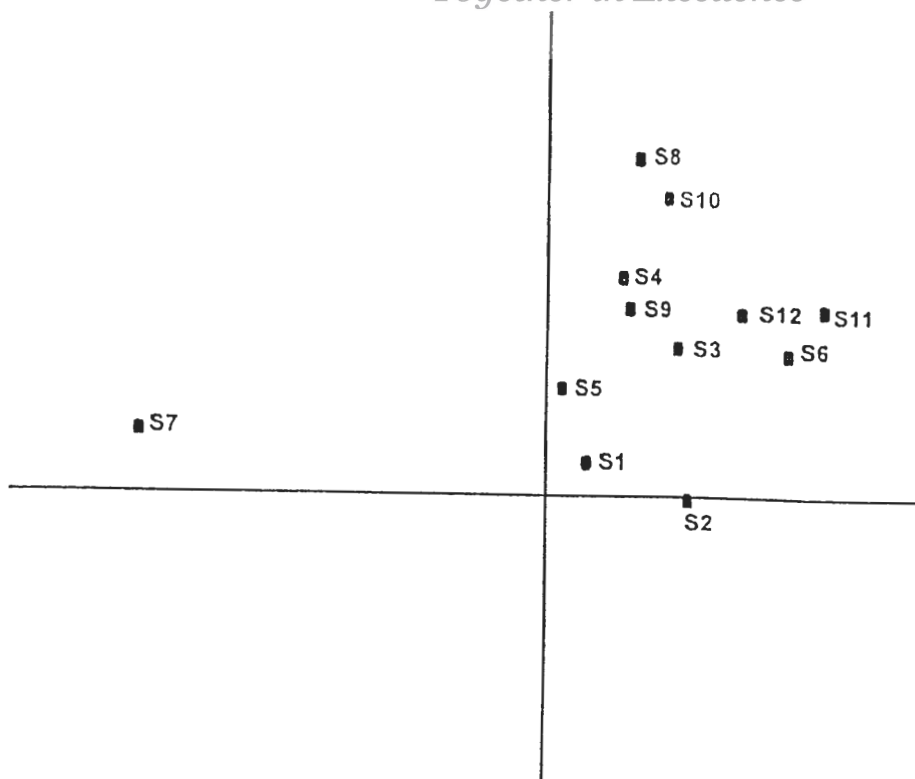
Figure 17 Distribution of quadrats at Saki

DCA exhibited a uniform plant specific distribution in all quadrats, the only exception being quadrat 7 (Figure 17). The species composition also appeared to be uniform and was characterized by a high percentage of bareground (43%), and the presence of plant species such as *Chrysocoma cilliata* and grass species such as *Digitaria eriantha* (6%), *Aristida diffusa* (6%), *Cynodon dactylon* (10%) and *Sporobolus africanus* (1%) (Figure 18). This appeared to be an indication of poor veld and might therefore be indicative of poor veld as referred to in Table 3.

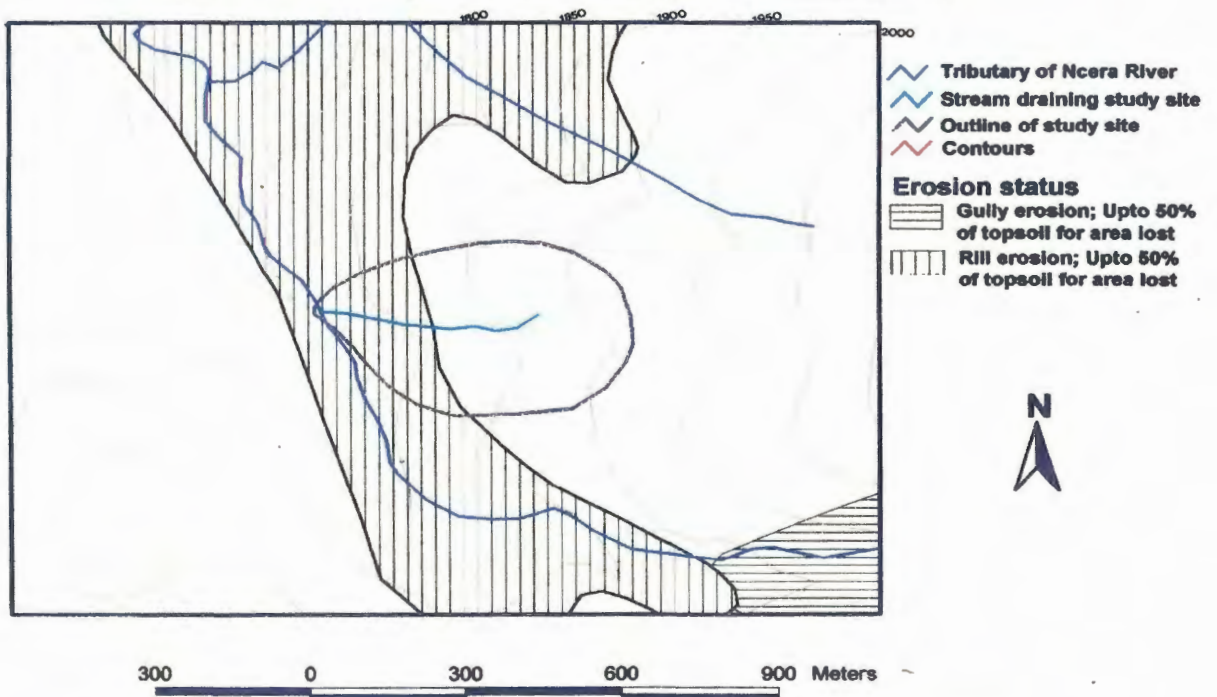
Figure 60 Contours and erosion patterns at the Ngqele catchment (1977)

of this soil type. The slope gradient at this site was at an angle of 14 degrees, which was a relatively gentle slope (Figure 60). Erosion seemed to be independent of the slope and the soil type. Only approximately 28% of the catchment showed signs of erosion.
